Monitoring Data Record

Project Title: Cashiers (R-2224A) COE Action ID: 200230408

Date Construction Completed: December 2003 Monitoring Year: (2) of 5

Year 2 - May 2005

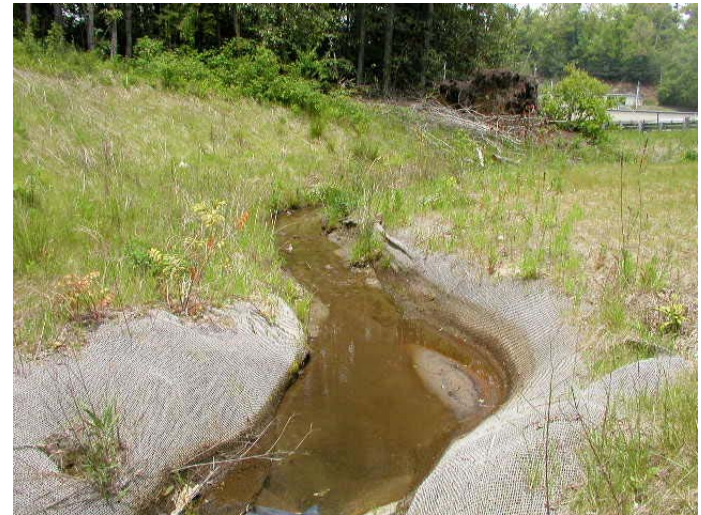
Photo 4

Bank failures are noted in photos 6, 7, and 9. These bank failures are due to the driveway culvert being undersized for the amount of water flowing during last years large rain events and the lack of woody vegetation on the streambanks. A large tree across stream just past (Photo 4) noted last monitoring period was removed. The Office of Natural Environment is in the process of setting up funds to repair the streambank failures, replant the streambank and buffer area, and replace the culvert.

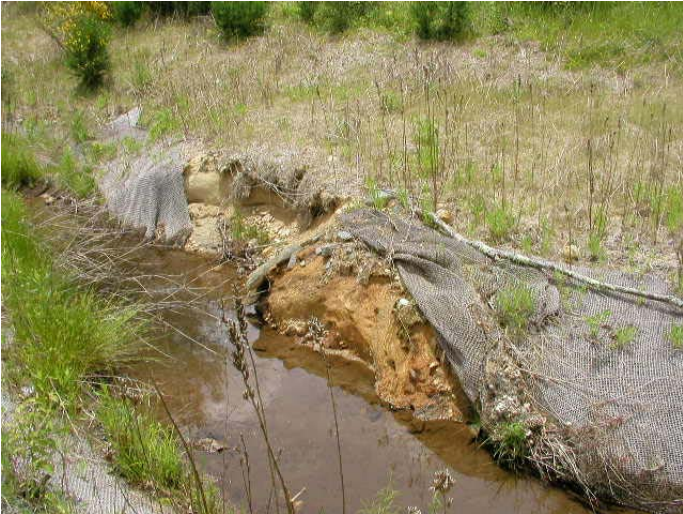
Photo 9 (bank failure)
